# ENGINEERING ORDER

DRAWING NO: 129-8053

1. DRAWING TITLE <b>Wear Damage Repair, R/H Fan Cowl</b>		2. PROGRAM <b>JET ASIA</b>	3. JOB NO.
4. TYPE OF DRAWING RELEASE <b>DER Review</b>	5. CONTRACT NO.	6. CURRENT REV <b>A</b>	7. UNINCORP'D ECO

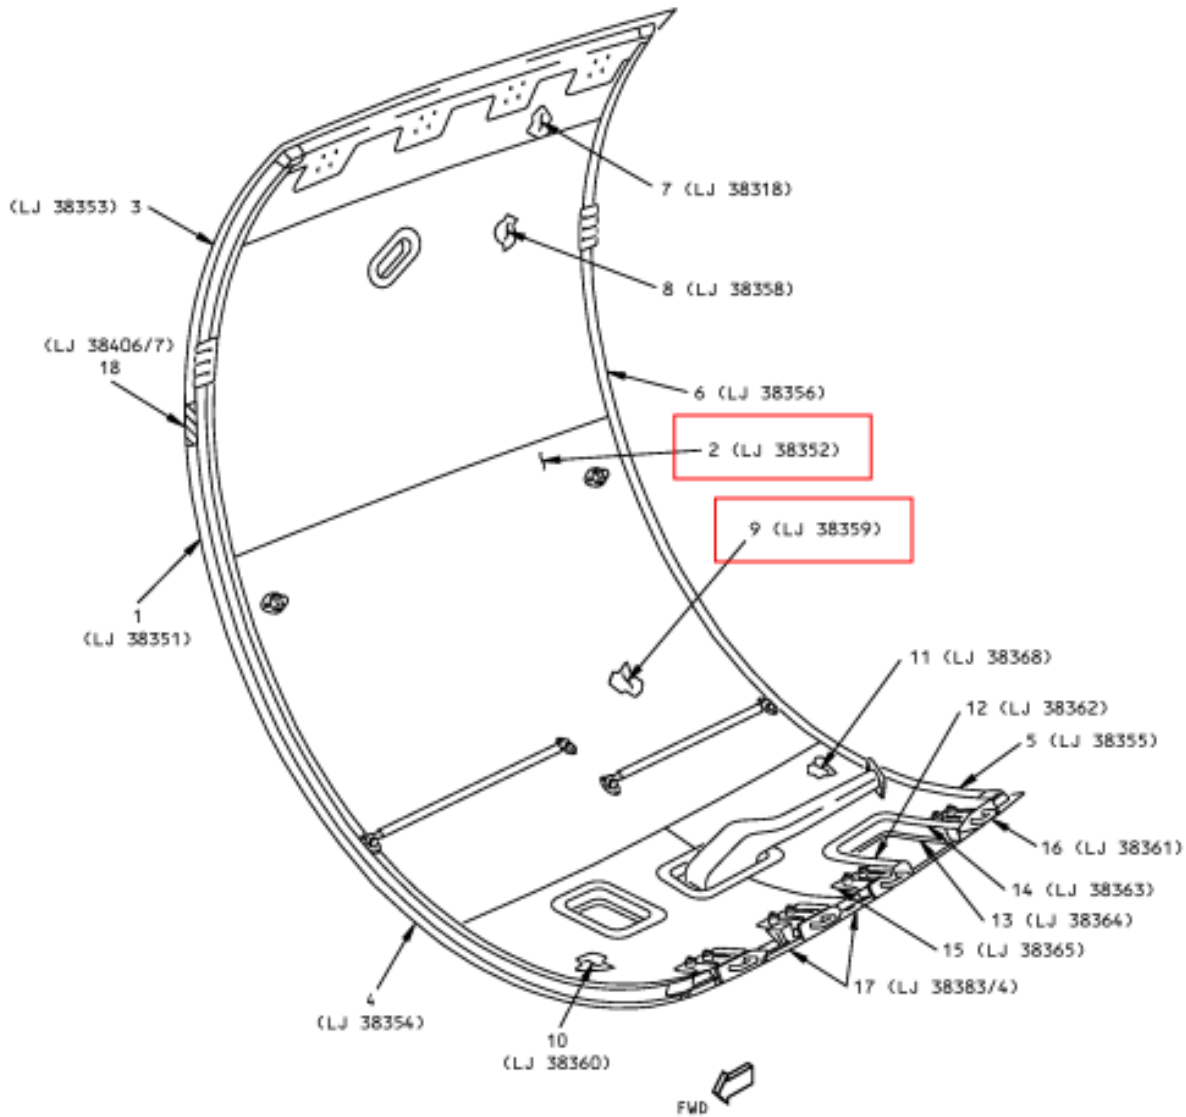
Figure 1. Fan Cowl Panel Identification

R/H fan cowl  
P/N:LJ38306  
S/N:944

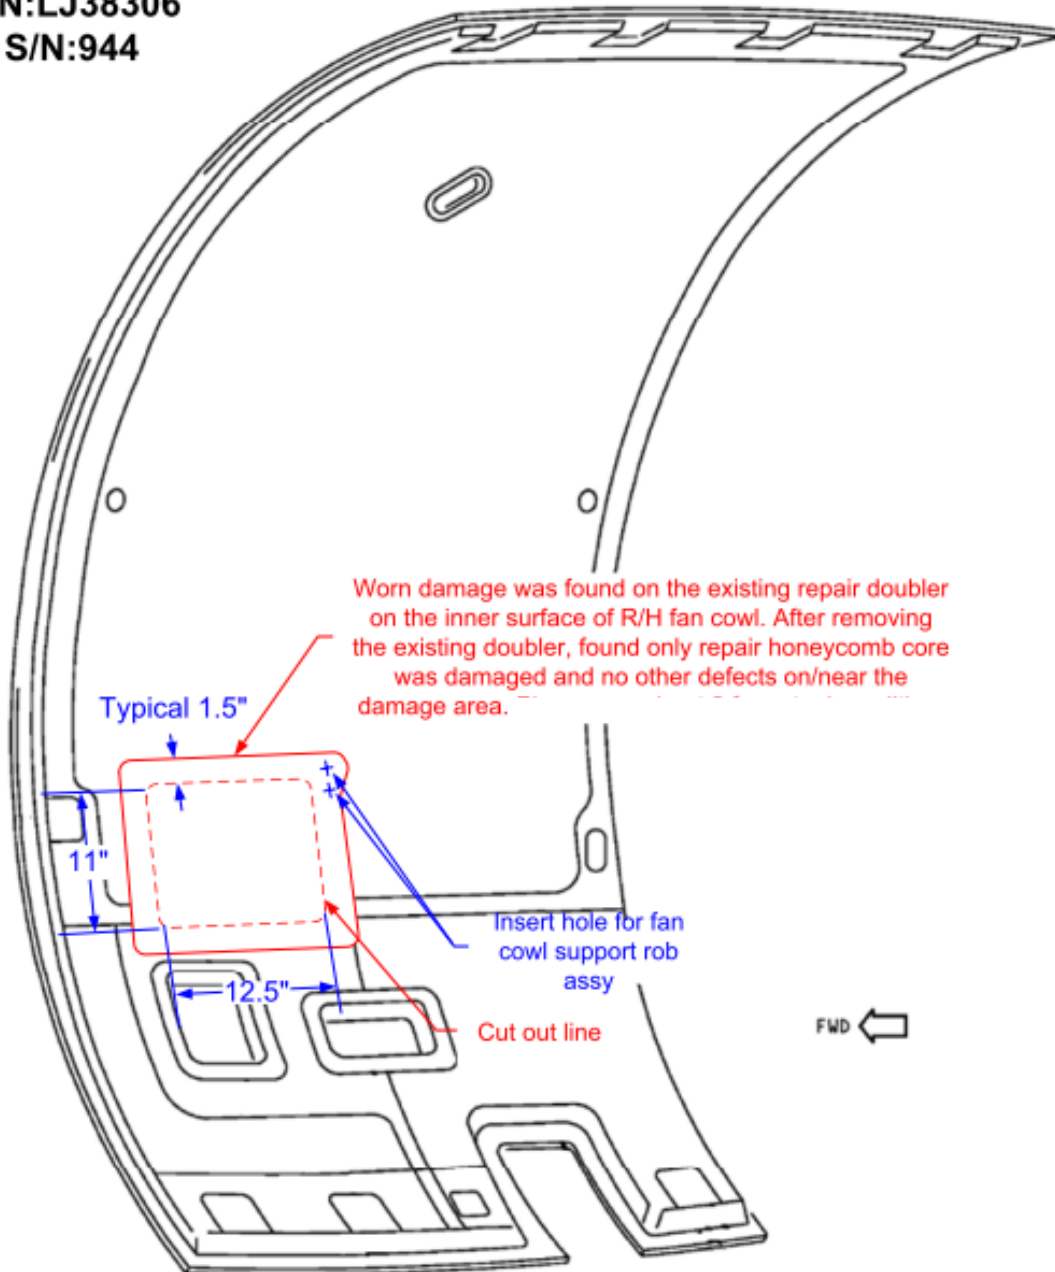
Figure 2. Showing repair area

1. Remove existing repair doubler from inner surface of R/H Fan Cowl Panel and remove the existing repair honeycomb core from the repair area.
2. Clean the reworked area per 767-300 SRM 51-00

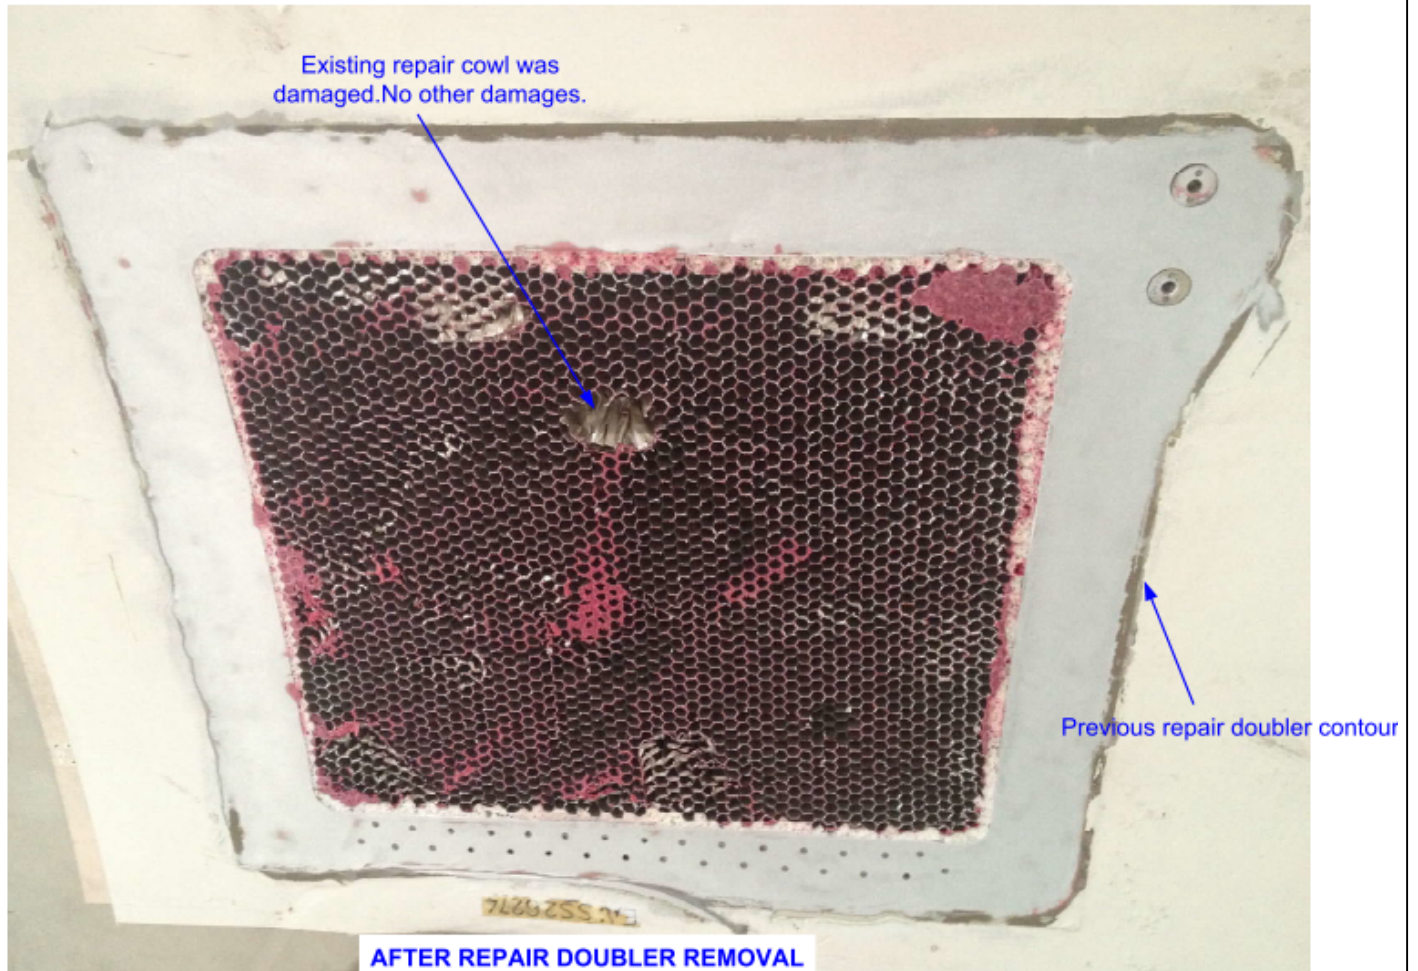
During inspection of datum A/C, wear damage to an existing repair was found on the R/H Fan Cowl Panel inner surface. The existing repair doubler was removed to reveal that the repair honeycomb core was damaged. See Figure 3 for detail.

Figure 3. Showing honeycomb damage

The existing repair honecomb core will be removed and a new core fabricated and installed. A filler and repair doubler of the same size and contour matching the original repair doubler will be installed. The original honecomb core P/N is 3-4/1/4/15 (5052)TD, but cannot be currently sourced from market and will be replaced with BMS4-4 type 4-10N. The prior repair utilized BMS4-4 type 4-10N instead of 3-4/1/4/15 (5052)TD, likely for the same reason.

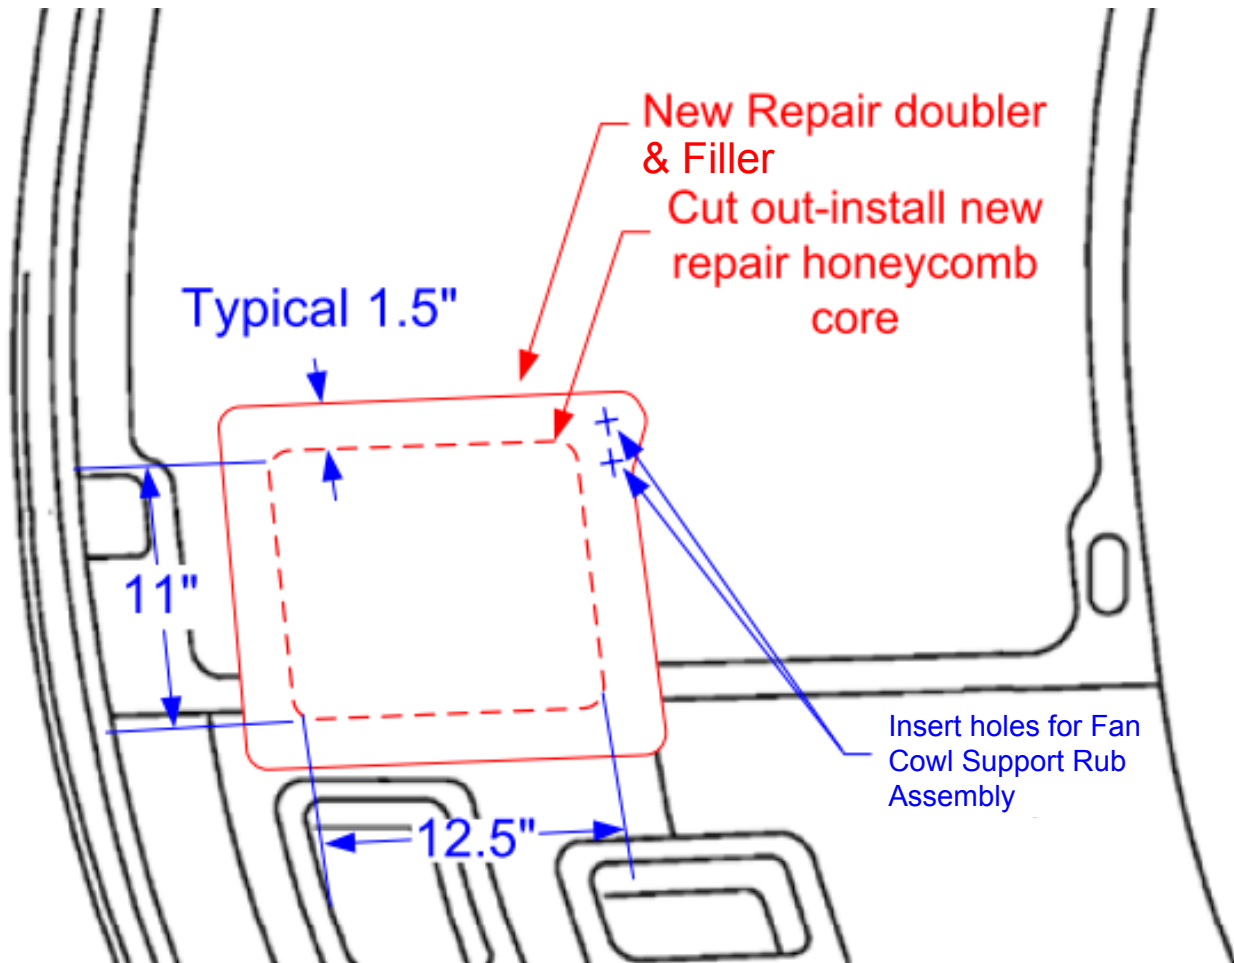
Figure 4. Showing repair area and dimensions

4. Fabricate a filler panel using Alclad 2024-T3 matching the thickness of the cowl inner skin with dimensions of 12.5" x 11.0" radiused to match the profile of the cutout (Figure 4). Apply chemical conversion coating to the fabricated doubler.

5. Fabricate a replacement plug of honeycomb core from BMS4-4 Type 4-10N as shown in Figure 4.
6. Prepare the bonding surfaces per 767-300 SRM 51070-10 using BOEGEL (AC-130) method.
