ENGINEERING ORDER

DRAWING NO: 135-8051

1. DRAWING TITLE Repair of damaged skin & stringers		2. PROGRAM	3. JOB NO.
4. TYPE OF DRAWING RELEASE DER Review	5. CONTRACT NO.	6. CURRENT REV NC	7. UNINCORP'D ECO

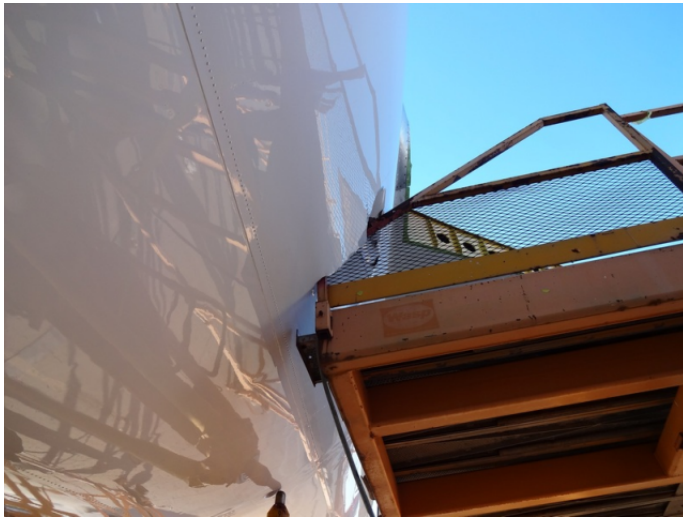
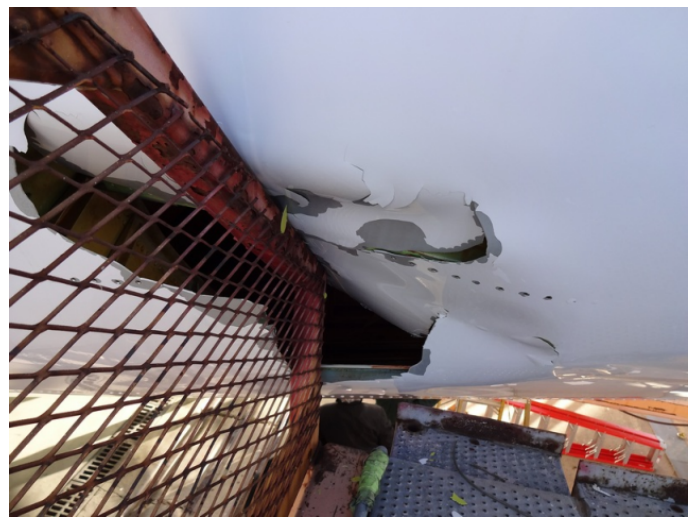
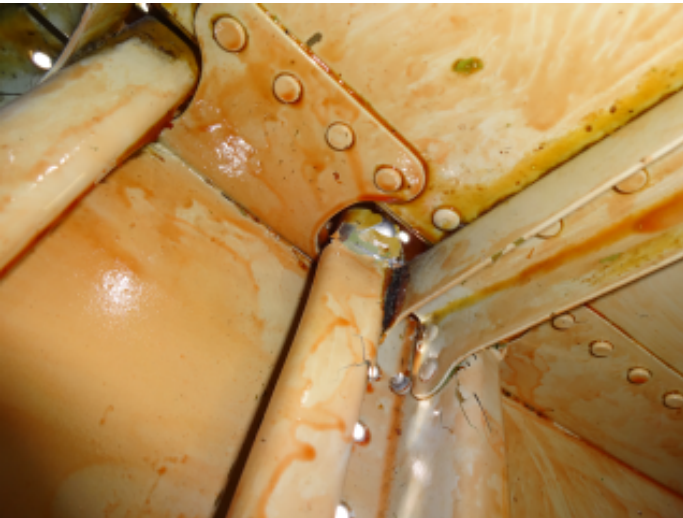
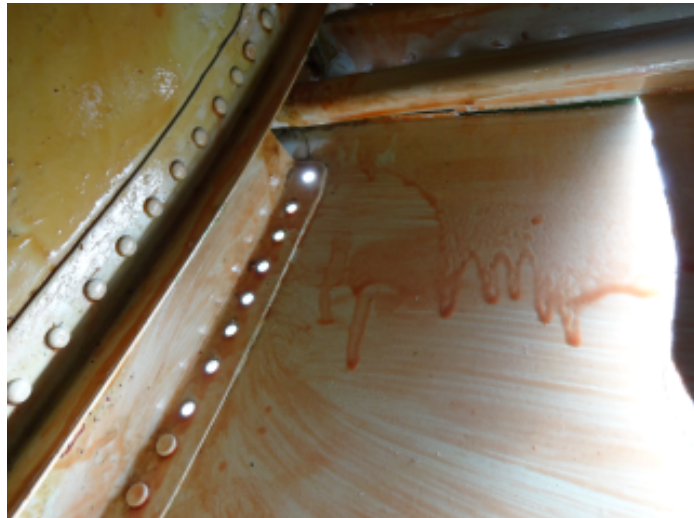
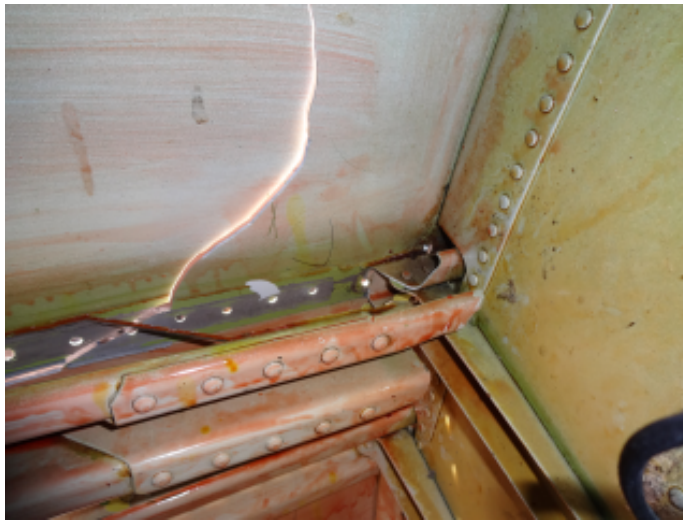
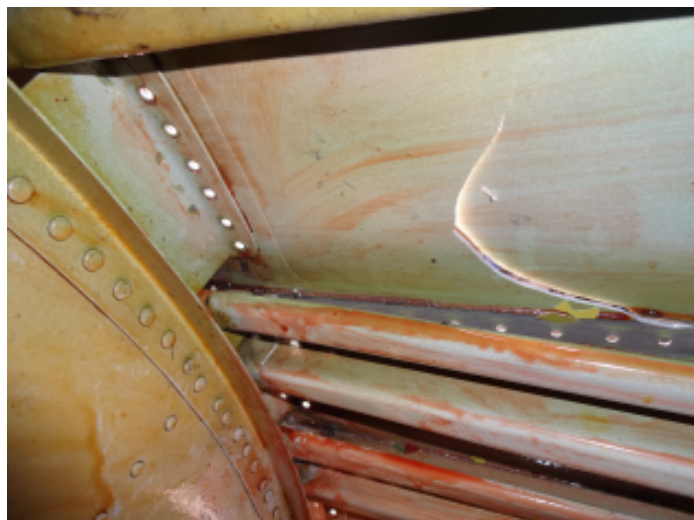
Figure 1. Photos of damage

During maintenance operations, a work platform pierced a section of skin in the unpressurised tail section aft of the aft pressure bulkhead (Figures 1,2). The impact occurred on the left side of the aircraft between frames 1629 and 1654.5. The frames were not damaged. The aircraft's skin and several stringers were broken or otherwise damaged and portions of those components must be replaced.

Remove damaged skin and stringers of LH fuselage skin and stringers S-20 through S-25 between FS 1654.5 and FS 1678 (Figure 3). Repair damaged stringers using aftermarket repair components and replacement parts. Repair skin by fabricating filler shims and adding an exterior doubler.
