ENGINEERING ORDER

DRAWING NO: 135-8051

1. DRAWING TITLE Repair of damaged skin & stringers		2. PROGRAM	3. JOB NO.
4. TYPE OF DRAWING RELEASE DER Review	5. CONTRACT NO.	6. CURRENT REV NC	7. UNINCORP'D ECO

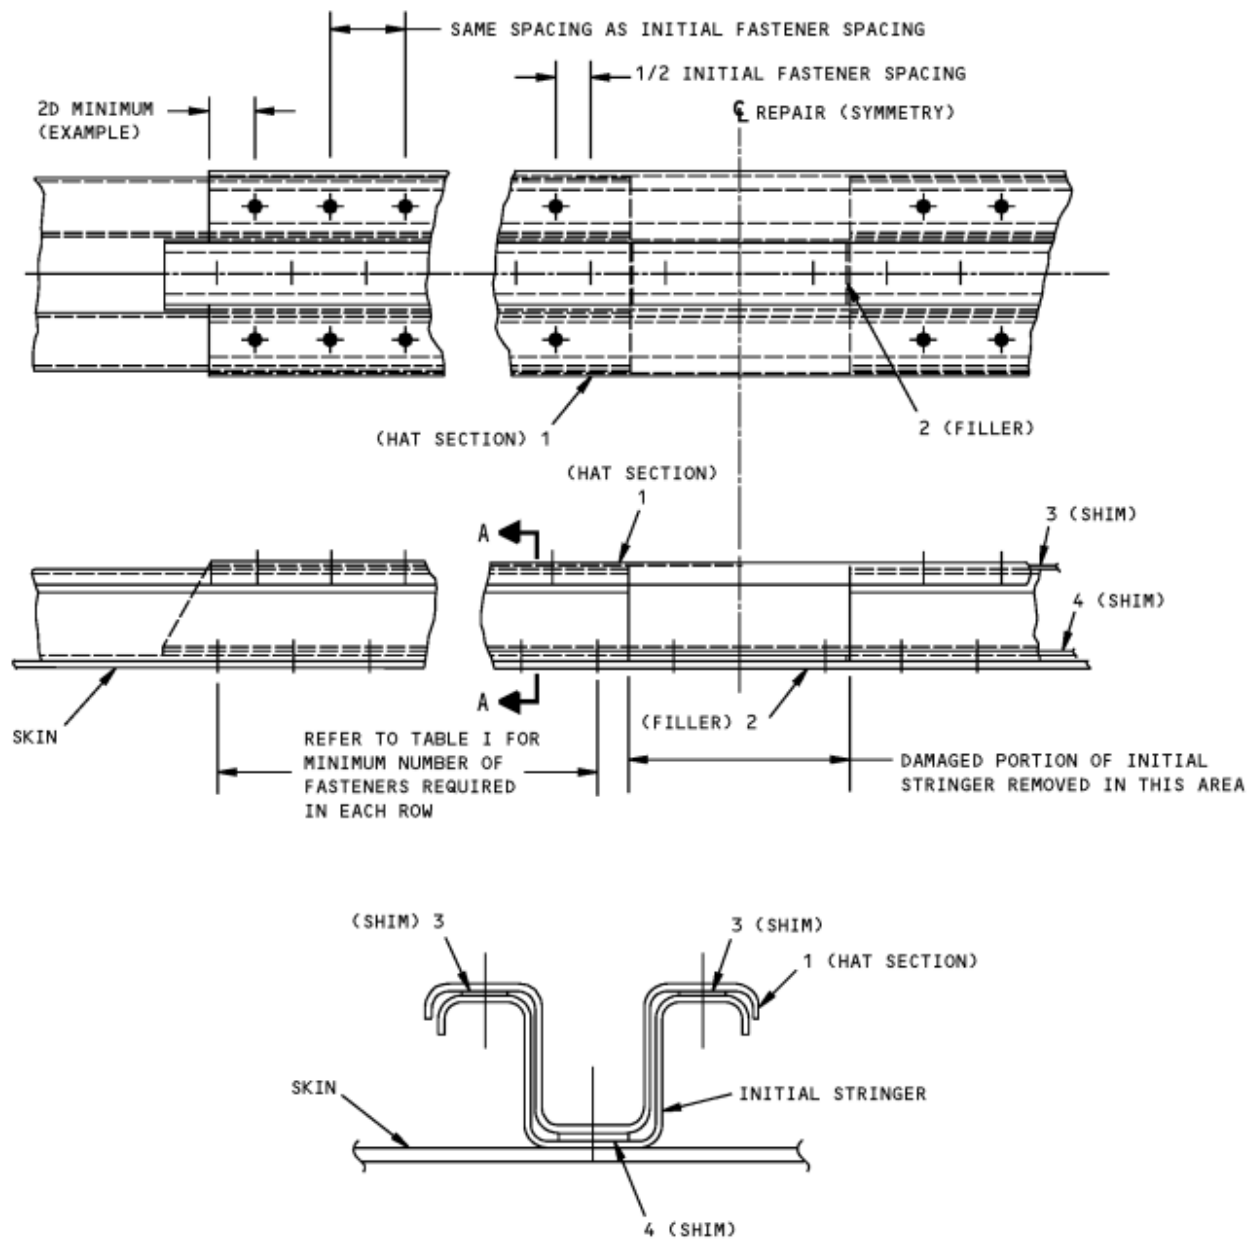
Figure 11. Stringer repair topology

Fuselage Stringer Repair S-21 thru S-39

3. Carefully cut and remove the damaged portion of stringers S-20L, S-22L, S-23L, S-25L between FS 1629 and FS 1707. Do not cut into the skin, and do not cut into the reinforcement radius fillers. It is acceptable to remove frame shear ties as required in order to extract the damaged stringers.

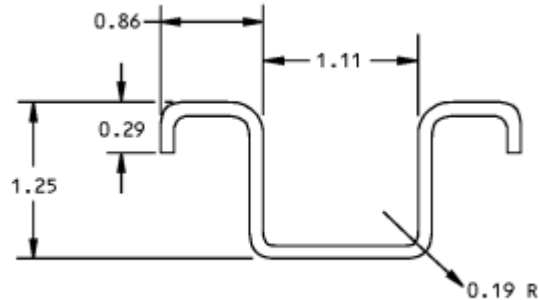
Figure 12. Stringer replacement parts

Purchased Parts

INITIAL SECTION GAGE	INITIAL SECTION	REPAIR SECTION		MATERIAL
		DETAIL III	DETAIL IV	
0.050	BAC1498-142	BAC1498-132		Clad 7075-T6
	TYPE I
